An Update on Dairy Cow Freestall Design

Nigel B. Cook, MRCVS
Ken Nordlund, DVM

School of Veterinary Medicine, University of Wisconsin-Madison

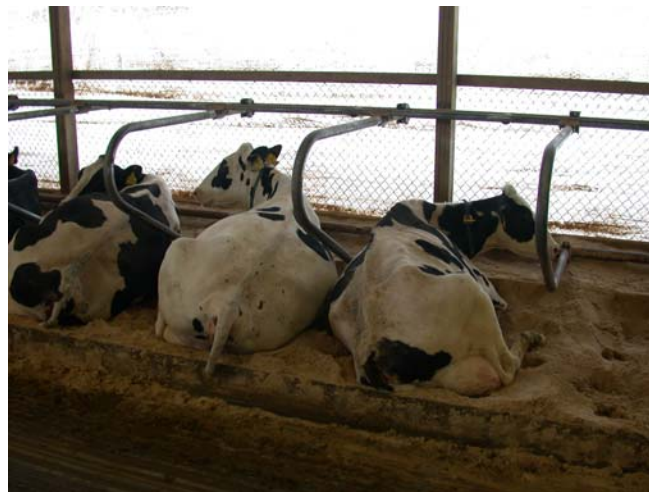
Figure 1. Re-modeled sand stalls 50 inches wide in a mature cow free stall pen.

Since our previous article, research has shown that increasing stall surface area has an impact on resting and standing behavior. A Canadian study found that cows lay down for 1.2 h/d longer in wider stalls (52 compared with 44 inches wide) and spent less time standing in the stall¹² (Figure 1). The most recent recommendations for resting area place stall widths at 48 inches for first lactation heifers, 50 inches for mature cows and 54 inches for pre-fresh cows, measured between dividers on center^{2,4}. Where mixed ages and sizes are penned together, we suggest using the 48 inch dimension, or be prepared to tolerate dirtier stalls. The distance from the rear curb to the brisket locator should be 68 to 70 inches for first lactation heifers, and 70 to 72 inches for mature cows, depending on their size.

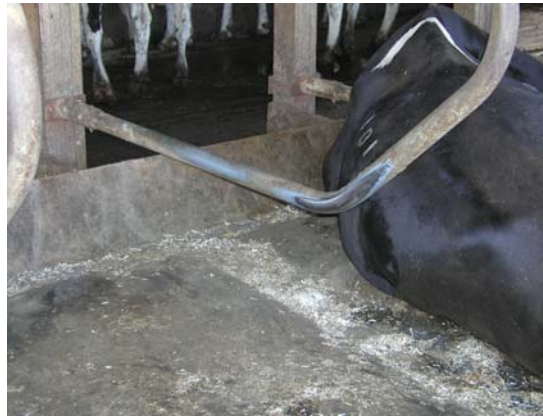
Figure 2. Brisket locators higher than 4 inches above the stall surface impede the forward thrust of the front limb when rising. Cows will tend to lie diagonally across the stall to give themselves more room. Note the long lower divider rail is rubbed shiny from cows lying against it.

We have also begun to appreciate more the impact of how the stall area is defined on cow movement and behavior. The brisket locator should be no higher than 4 inches above the stall surface so that the cow could lie with one forelimb extended if she chose to, and be able to thrust the fore-limb forward during the rising motion⁸. This forward thrust over the top of the brisket locator is a vital behavior that we would do well not to inhibit. Failure to provide for this movement is one of the major factors influencing how the cow positions herself in the stall. In stalls with high brisket locators, or where concrete has been filled above the level of the stall behind the brisket locator, cows will tend to lie diagonally in order to create a little more space for front leg movement when rising, along the diagonal (figure 2).

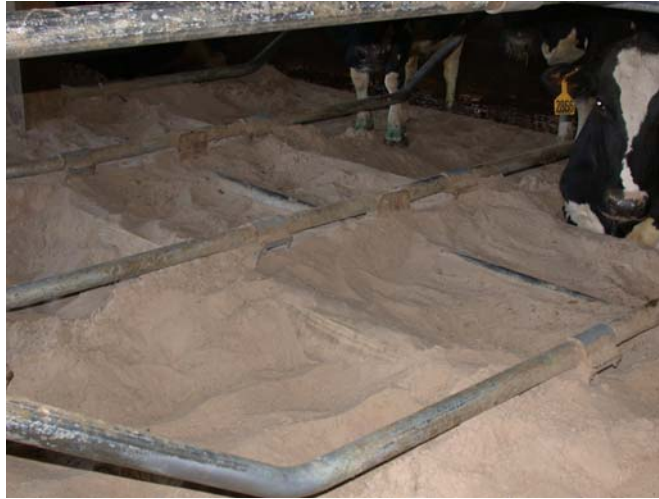
Figure 3. A horizontal mounting bar is retained in this stall, but mounted below the bedded surface in a sand free stall. The bedding has been moved to show the bar and the right angle mounting bracket.

We appreciate that the horizontal mounting bar makes construction easier, however, when mounted in the area at the end of the lunge between the stall platform and a height of 40-42 inches above it (referred to as the ‘bob zone’), they will impede the movement of the head when lying down and rising, and force more side-lunging. New stall dividers have improved vertical attachments that are mounted into the stall platform. One sand stall facility used a right angle mounting attachment to drop the horizontal bar down below the bedded level (figure 3). Both designs have been successful.

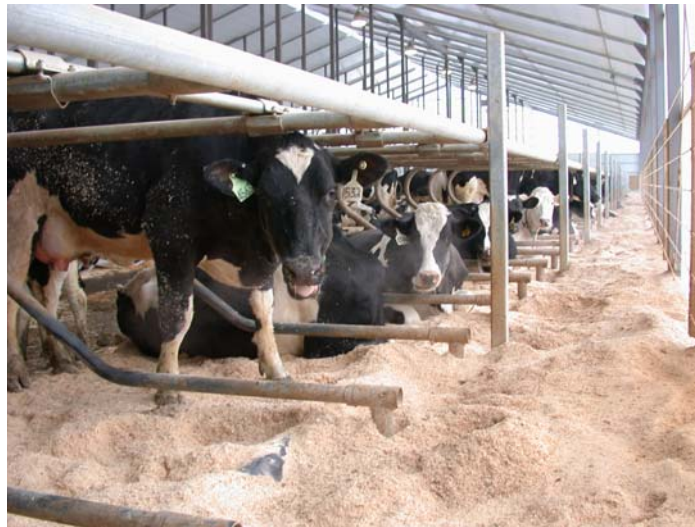
Figure 4. An open front stall against a side wall, with dividers mounted to provide space for front lunging.

It would appear that the modern Holstein cow requires 10 feet of length against a side wall to front lunge². Stall dividers are not freely available for this length of stall. However, they may be mounted with a separation between the vertical mount and the side wall, keeping the cow's head away from the curtain wall (figure 4).

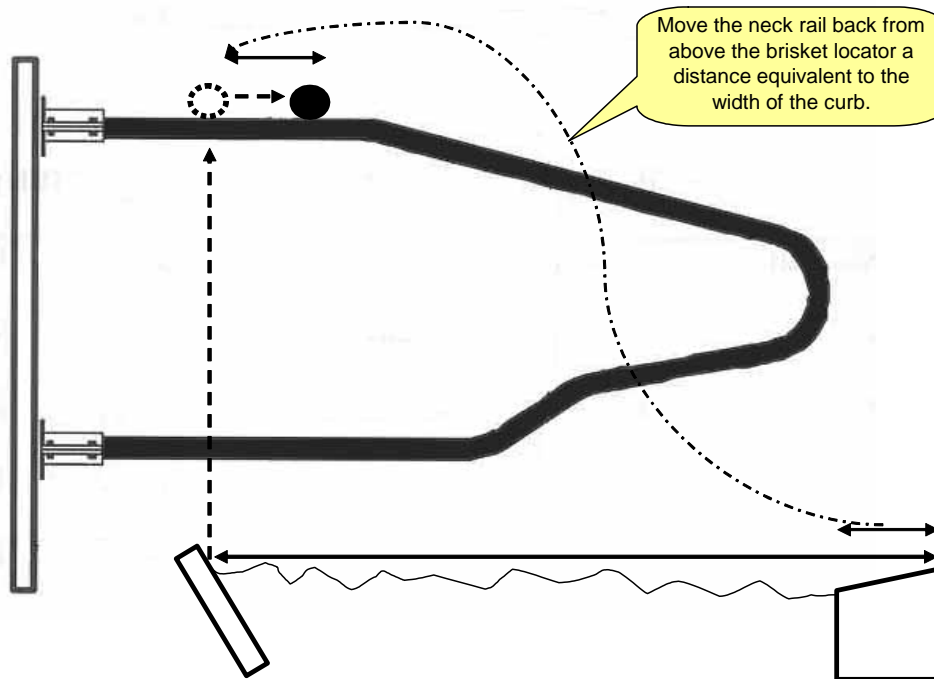
Figure 5. Correct location of the neck rail in a loose bedded stall with a raised rear curb by moving the rail back from above a correctly positioned brisket locator a distance equivalent to the width of the rear curb.

At this location in sand stalls, the cows will stand diagonally across the stall platform with their rear feet inside the curb. When these cows urinate and defecate, the rear of the stall becomes excessively soiled. Our research confirms that lame cows in sand stalls do not stand for long periods of time and maintain normal daily lying times⁵. We also know that the elevation of the front feet and stresses on the rear feet in a sand stall are not equivalent to that in a mattress stall, should the cow decide to perch, as the degree of elevation is usually much less. Therefore, our recommendation, in stalls with loops that locate the neck rail 44 to 50 inches vertically above the stall surface, is to move the neck rail from above the brisket locator toward the rear, a distance equivalent to the width of the rear curb in a sand stall. We therefore prefer curbs that are not too wide. Thus, in a mature cow sand stall with 72 inches from the rear lip of the curb to the brisket locator, with a 6 inch wide curb, the neck rail should be located $72 - 6 = 66$ inches from the rear lip of the curb. For first lactation heifers with 68 inches from the rear curb to the brisket locator, the neck rail should be located $68 - 6 = 62$ inches from the rear lip of the curb. In stalls with neck rails lower than 44 inches, the farmer must be prepared to make further adjustments to the neck rail location to ensure that the cow can rise without hitting the rail. At this location, the cow will be forced to perch, with the rear feet in the alley. We are prepared to tolerate this in sand stalls for the reasons outlined above, and in this location soiling of the stall bed will be prevented.

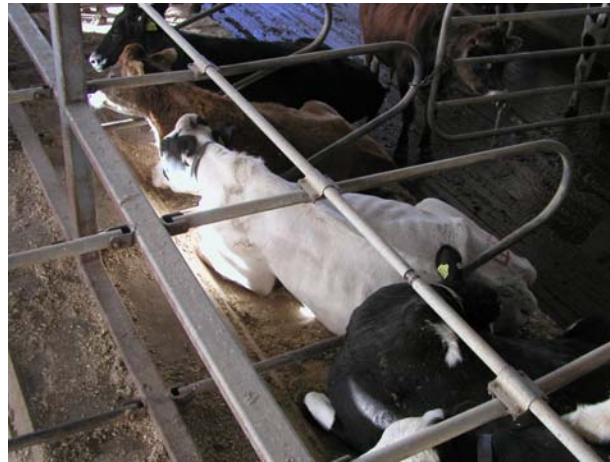
Figure 6. Cows lying diagonally across stalls that are head to head layout, with a bob zone obstruction and concrete fill behind a high brisket locator.

Diagonal lying is a complex issue caused by a variety of stall design factors – involving lunge space, standing position, brisket locator design and social obstructions (figure 6). The stall design must allow for the normal rising and lying movements of the dairy cow. In particular, we must provide forward lunge room for the head, an unobstructed bob zone and we must allow for the forward stride of the forelimb as the cow rises, so that the leg can take the weight of the cow and facilitate the rising motion. Diagonal lying is a response by the cow to a failure to meet some or all of these requirements and we have included a flow diagram to help the investigator consider the possible causes and solutions.

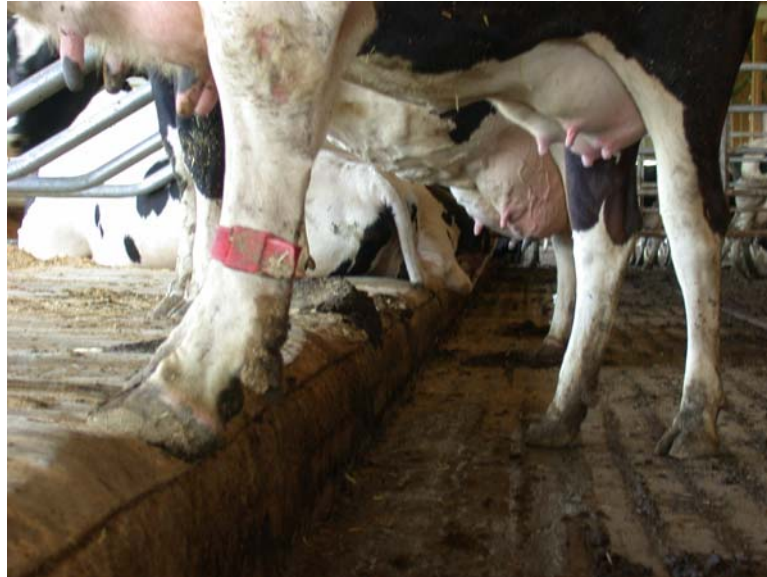
Figure 7. Whether a cow stands with all four feet on the stall platform or perches, with the rear feet in the alley, is probably a function of poor stall design and lameness.

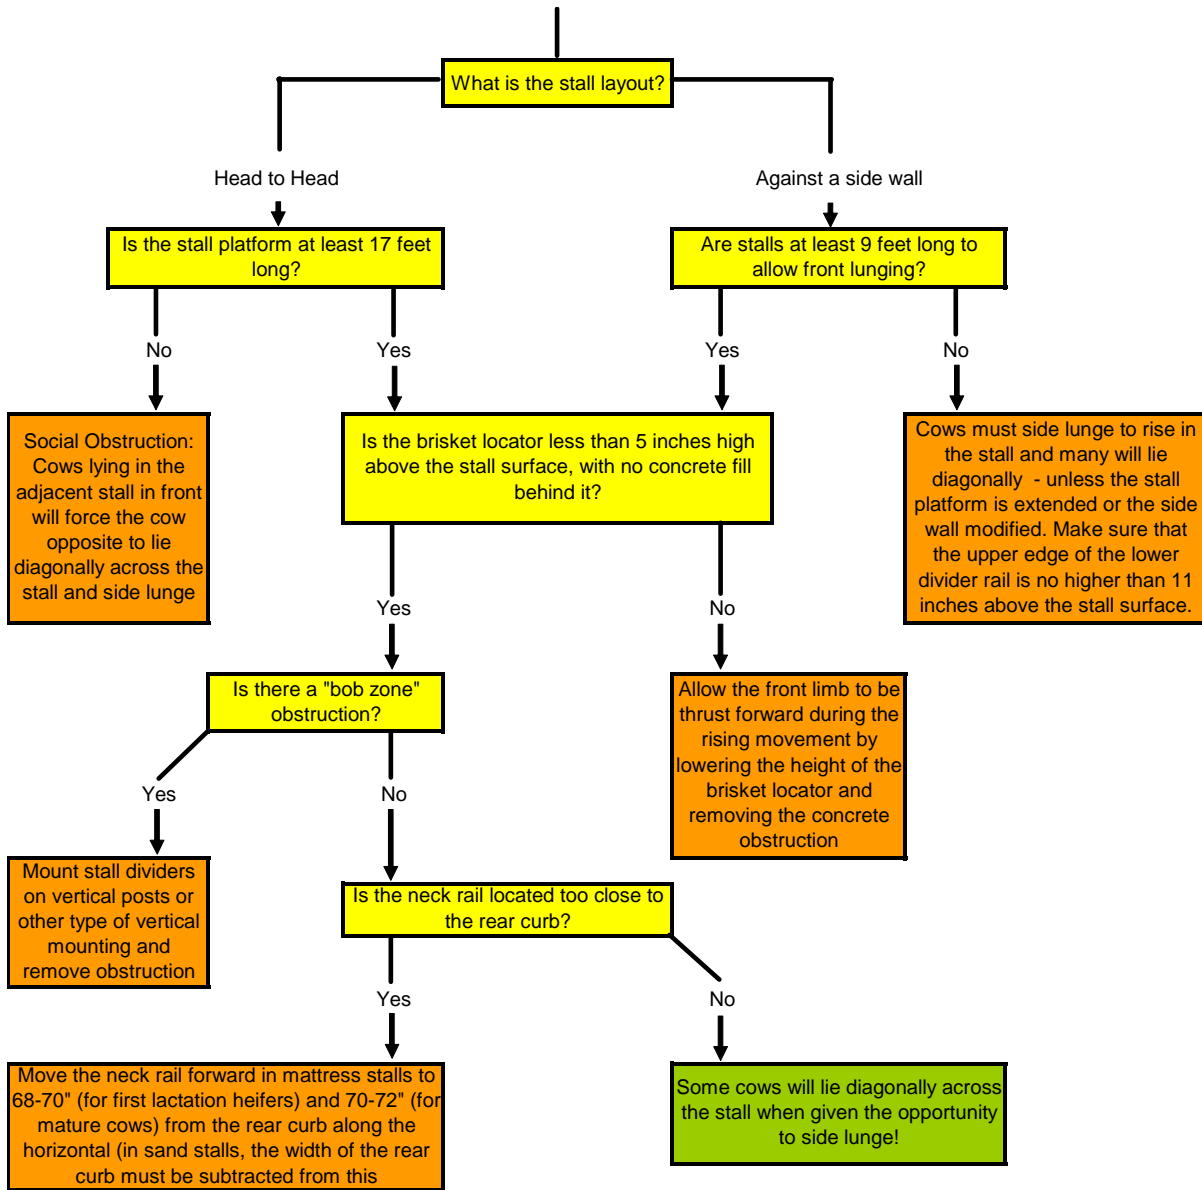
Figure 9. A flow chart for trouble-shooting reasons for diagonal lying in free stall barns.
